# STRUCTURAL REHABILITATION

## Monitoring the Health of a Building during and after Rehabilitation

By Dominick R. Pilla, P.E., C.E., S.E., R.A., Jorel Vaccaro, P.E. and Justin Wilde

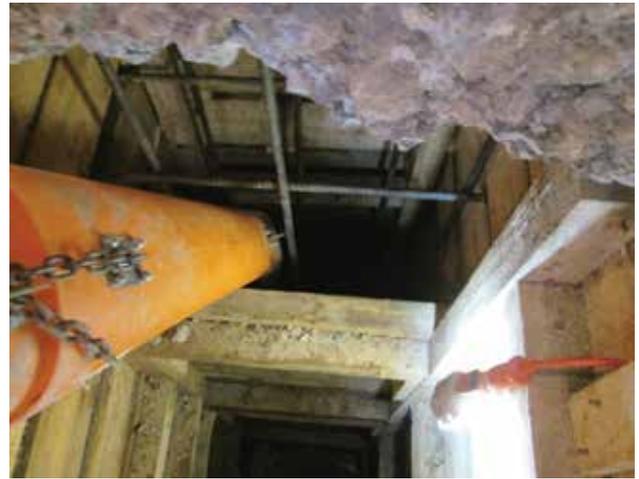
Figure 1. Installing an underpin beneath foundation.

The New York City Building Code, Section 1814.3, requires this monitoring during any underpinning activities (Figure 1). Monitoring is also required during any site work within ninety feet of a Landmarked Building, a designation specified by the NYC Landmarks Preservation Commission (LPC). Technical Policy & Procedure Notice 10 of 1988 (TPPN 10/88)

The next stage, underpinning of the rubble foundation, then proceeds in sequenced excavations. Excavation width is limited to four feet, pin width is limited to three feet, and all efforts are made to minimize the disturbance of existing soils. Unfortunately, lateral movement and vertical settlement approaching the 1/4 inch limit are observed during the underpinning process (Figure 5). As a result, work is stopped and additional bracing and steel reinforcement is designed by the engineer to bolster the frame of the building. Additional targets are applied to the exterior face of the building in order to record a more precise profile (Figure 6) and monitoring frequency is increased to a 48 hour schedule. The additional shoring is developed to essentially create a temporary steel diaphragm, "grab" the existing masonry façade, and connect it directly to the horizontal steel bracing attached to the adjacent building. This effectively arrests all movement and the contractor is able to proceed with underpinning, completing it without further movement.

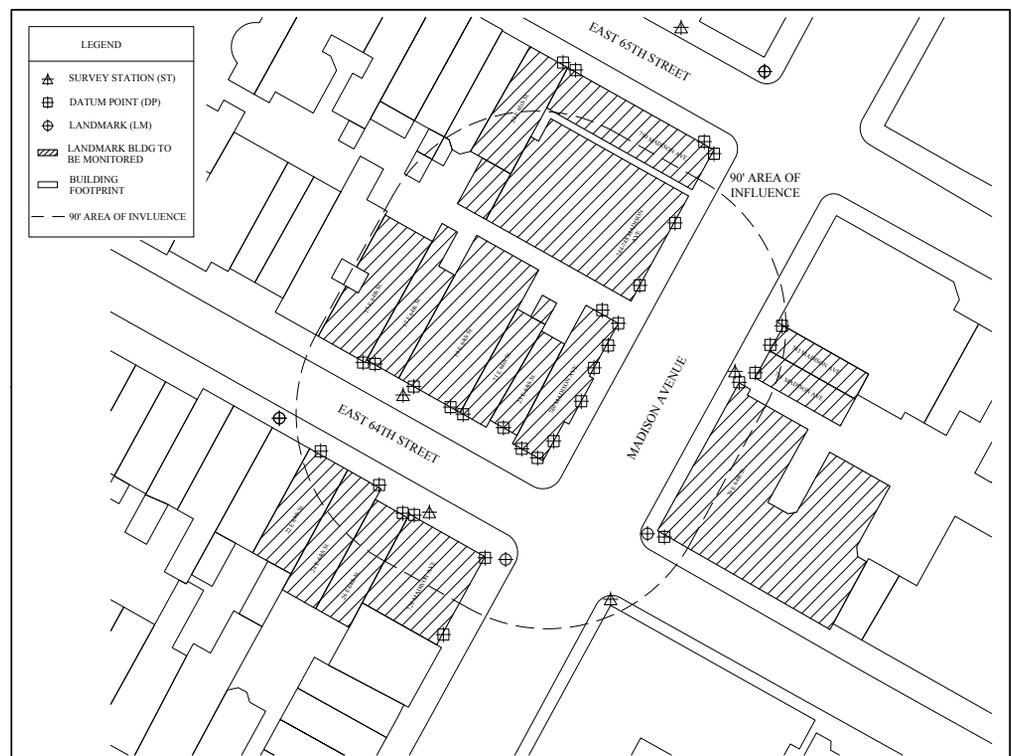
Figure 2. Monitoring plan diagram with 90 foot radius indicated.

The LPC requires monitoring of all landmarked buildings within 90 feet and in all directions of the work being performed (Figure 2). While this radius may seem

excessive based on an average depth of excavation, say 20 feet, and an average angle of soil repose of 45°, the 90 foot radius also takes into account the potential for vibratory equipment to affect soils under buildings at this distance as a vibration wave propagates outward. While direct effects of soil removal are not anticipated at a 90 foot distance, sandy soils can settle during pile-driving or rock blasting, and effects of these vibration loads can be observed at this distance.

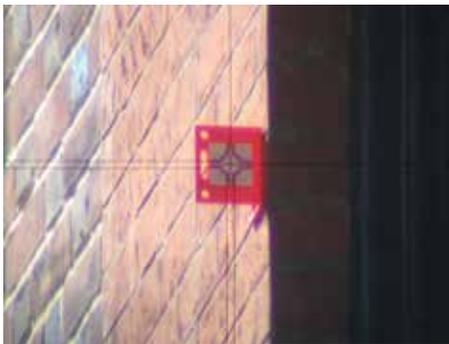
Figure 3. Collimation of a target through a total station.

Optical monitoring consists of the installation of targets on the façade (Figure 3) of each building to be monitored. Typically, targets are installed at a height equal to the 2<sup>nd</sup> floor or 3<sup>rd</sup> floor framing and spaced along the façade every five to ten feet horizontally. The first signs of any settlement are easily observable in the data when arranging targets in this orientation. This is because placement in the lower floors allows for any localized settlement to be observed. Separation and cracking can

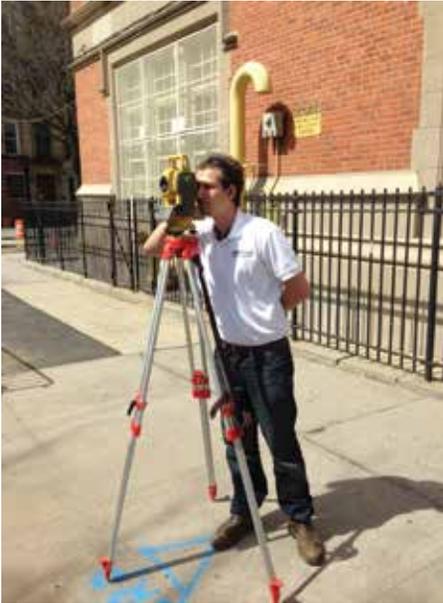
Figure 4. Surveying of monitoring points.

Optical monitoring is performed with a total station (*Figure 4, page 16*) and typically occurs multiple times per week. The frequency is increased if the monitored structure is deemed particularly vulnerable or if any movement trends are observed. During data collection, reference points are recorded in the form of previously-set benchmark target locations. The recorded monitoring data is compared to these benchmark locations to calculate any displacements that have occurred in three directions – the in-plane lateral (sideways) direction, out-of-plane lateral direction, and vertical (Z) direction. The directions are not always described in the same fashion as typical surveying coordinates, i.e. as Northing and Easting, because the direction relative to the face of the material being monitored is of primary concern.

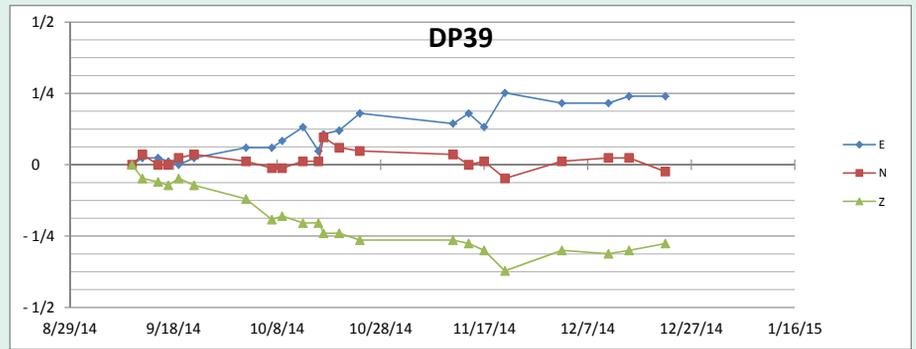
Figure 5. Graph of the displacement of a monitoring point.

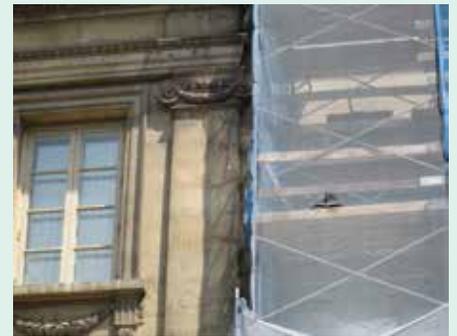
Figure 6. Typical target on landmarked building.

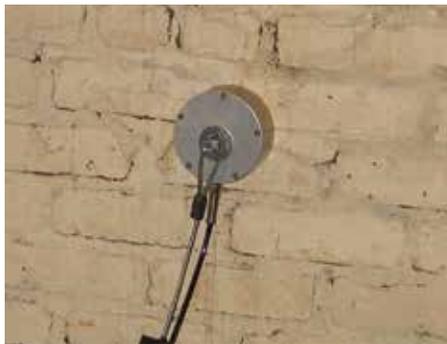
*Figure 7. Attachment of a vibration monitor geophone.*

The vibration monitoring equipment, commonly utilized to collect seismic data and blast activity monitoring during mining, consists of a tri-axial geophone (*Figure 7*) to convert movement into an electrical signal. The signal is then recorded and, when coupled with a modem or internet-connected hardware, can be uploaded to the monitoring engineer's server for real-time data review and immediate event alerts. The vibration monitors are placed on all adjacent and contiguous foundations surrounding the project site. A microphone can also be incorporated into these systems, which allows for the recording and monitoring of decibel level caused by the construction.
